Manhole Inspection Summary

Manhole # S09OO1020MH

Insp Date: **1/21/09 11:31 AM**

Location Address: **3301 GARRISON AVE**

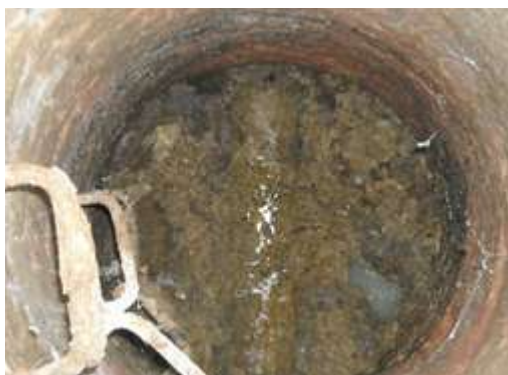
Defect 1

Condition: ☐ Sound ☐ Cracked ☐ Root Intrusion ☐ Deteriorated ☐ Leaks ☒ **Debris**

GREASE ON BENCH AND IN CHANNEL

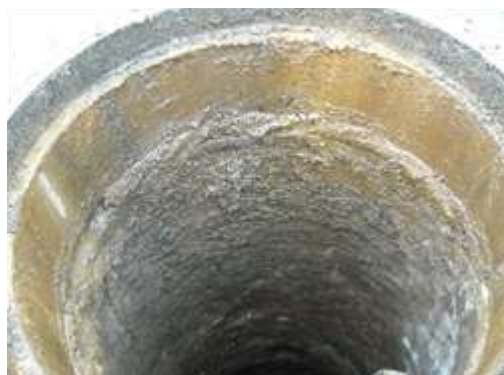
Defect 4

Infiltration: ☐ None ☐ Joint ☐ Cracks ☐ Mortar ☐ Roots ☒ **Wall**

INFILTRATION EVIDENCE ON CORBEL WALL

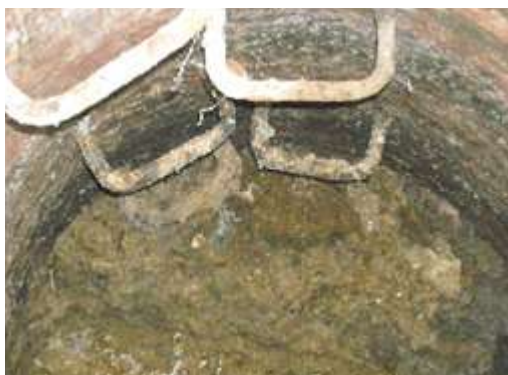
Defect 3

☒ **Evidence Of Surcharge** Depth: **4** (ft.) ☐ Active Surcharge Present

SURCHARGE EVIDENCE ON STEPS

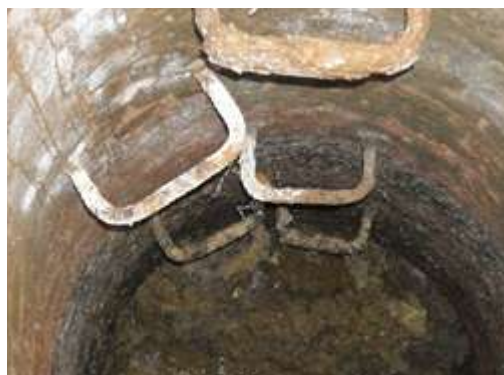
Defect 2

Count: **6** Missing: **0** ☒ **Corroded**

CORRODED STEPS

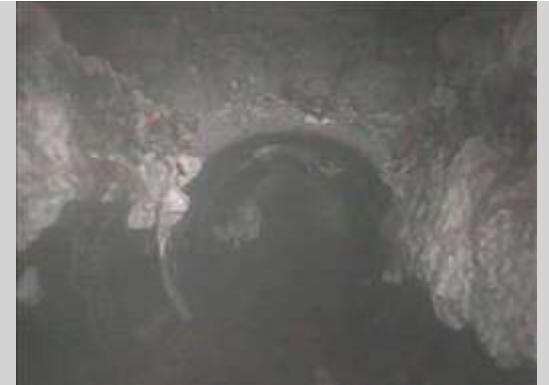
12 O'Clock Outflow

Pipe Height: **9.6** (in.) Rod and Bar (Angled)
Pipe Material: **Clay** ☐ Pipe Lined
Invert Depth: **11.82** (ft.) Flow Characteristics: **None**
Deposits: ☐ None ☐ Mud ☐ Sludge ☐ Debris ☒ **Grease**
Silt Depth: **6** (in.) Deposits Extent: **Heavy**
Infiltration: **None** Pipe Seal Cond: **Sound**

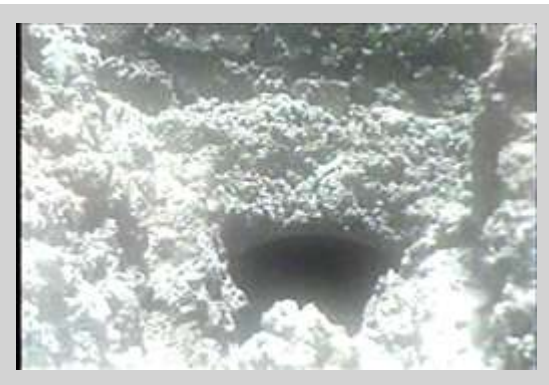
4 O'Clock Inflow

Pipe Height: **7.2** (in.) Rod and Bar (Angled)
Pipe Material: **Clay** ☐ Pipe Lined
Invert Depth: **11.76** (ft.) Flow Characteristics: **None**
Deposits: ☐ None ☐ Mud ☐ Sludge ☐ Debris ☒ **Grease**
Silt Depth: **4** (in.) Deposits Extent: **Heavy**
Infiltration: **None** Pipe Seal Cond: **Sound**

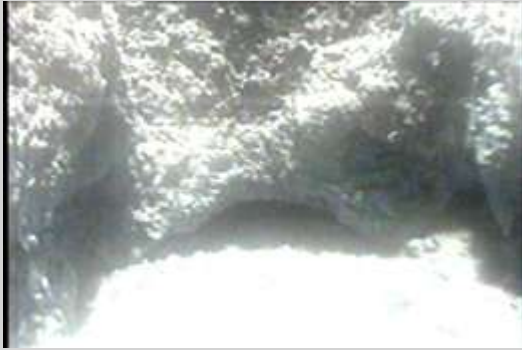
6 O'Clock Inflow

Deposits: ☐ None ☐ Mud ☐ Sludge ☐ Debris ☒ **Grease**

Silt Depth: **5** (in.) Deposits Extent: **Heavy**
